# Manhole Inspection Summary

Manhole # S05UU1012MH

Insp Date: **9/6/06 9:18 AM**

**Location** Address: **3500 W NORTHERN PKWY**

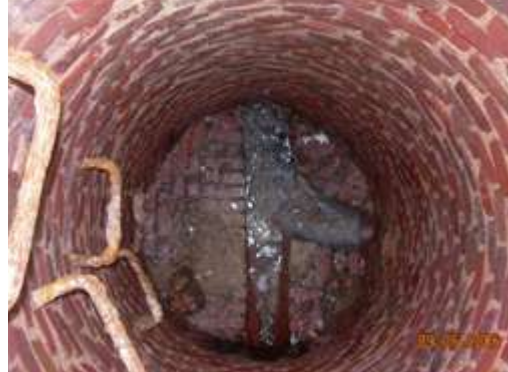
Top View

Adjustment and Barrel infiltration.  
Evidence of surcharge - Bench debris.  
Channel debris. Corroded steps.

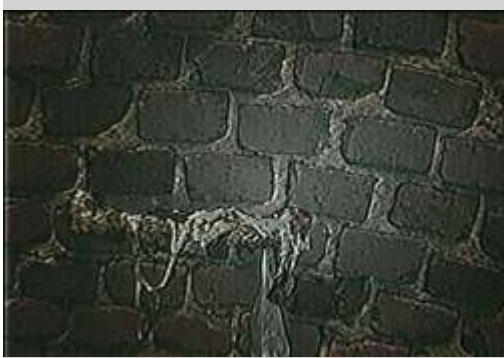
Evidence of surcharge

Barrel deterioration and infiltration.

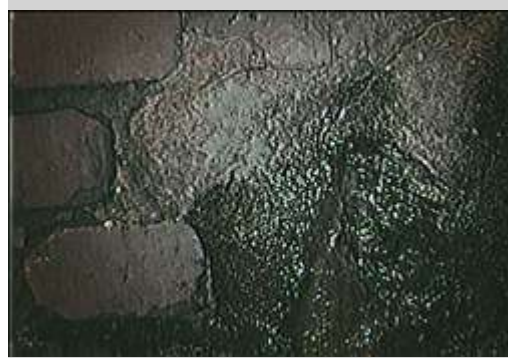
Defect

Barrel deterioration and infiltration. (above the I6)

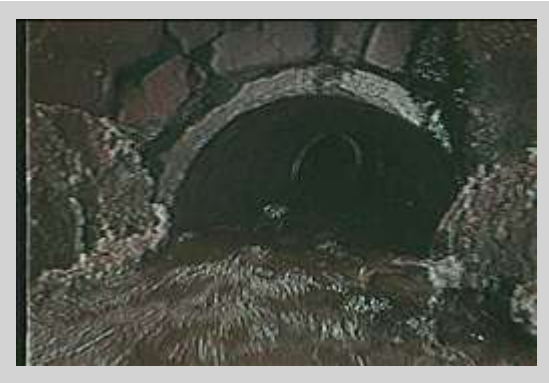
### 10 in. Circular Gravity Sewer Pipe Out @ 12 O'Clock

Barrel deterioration and infiltration. Channel deterioration.

Infiltration: **Evidence** Pipe Seal Cond: **Broken**

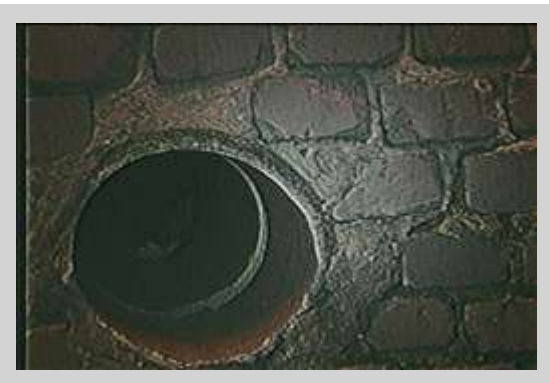
### 8 in. Circular Gravity Sewer Pipe In @ 3 O'Clock

Barrel deterioration and infiltration.

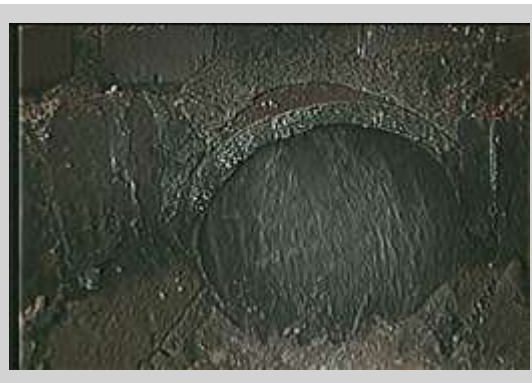
### Drop In @ 3 O'Clock

Barrel deterioration and infiltration.

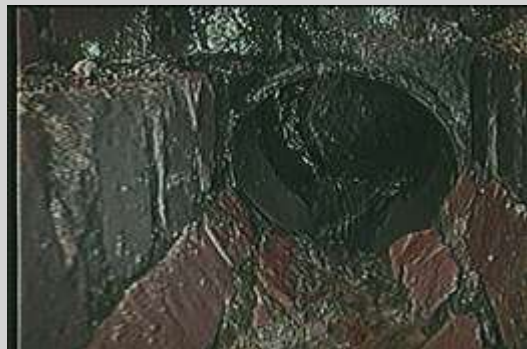
Pipe In @ 6 O'Clock

Barrel deterioration and infiltration. Channel deterioration.

Infiltration: **Evidence**
